Manhole Inspection Summary

Manhole # S35OO1007MH

Location Address: **322 RADNOR RD** Cross Street: **CROWSON AVE**

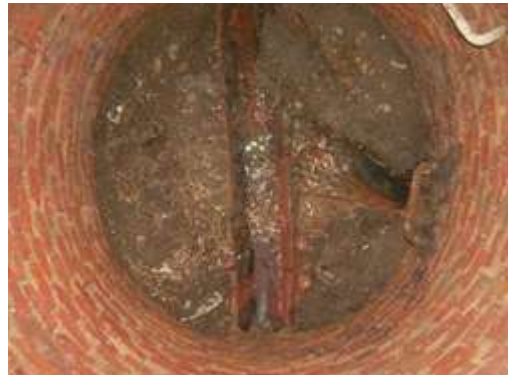
Top View

Barrel root intrusion and infiltration.
Corroded steps. Evidence of surcharge -
Bench debris.

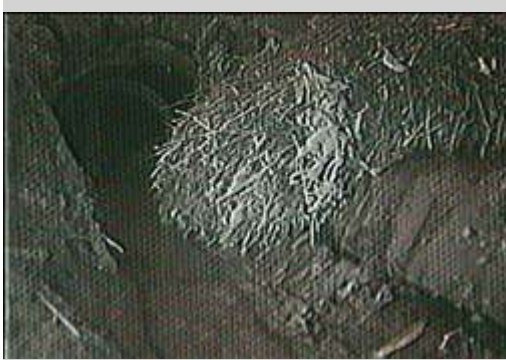
Defect

Bench root intrusion. Channel
deterioration.

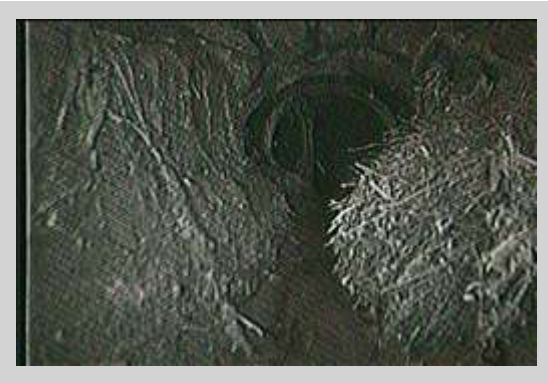
8 in. Circular Gravity Sewer Pipe Out @ 12 O'Clock

Channel root intrusion.

Infiltration: **Evidence** Pipe Seal Cond: **Roots**

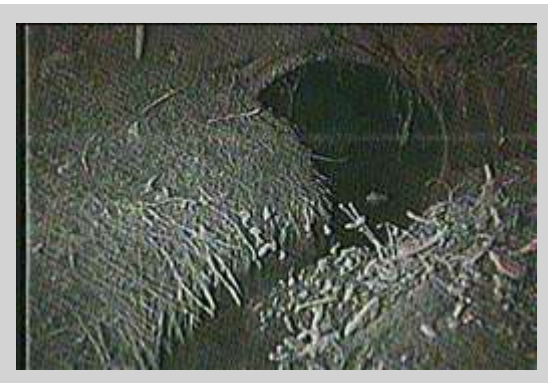
8 in. Circular Gravity Sewer Pipe In @ 4 O'Clock

Bench and Channel root intrusion.

Infiltration: **Evidence** Pipe Seal Cond: **Roots**

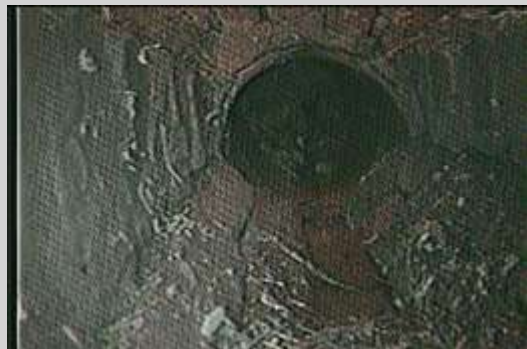
Pipe In @ 6 O'Clock

Barrel deterioration and infiltration. Channel deterioration. (Capped)

Infiltration: **Evidence**

Pipe Seal Cond: **Cracked**
